PISTON ROD DAMAGE (S1107-1)

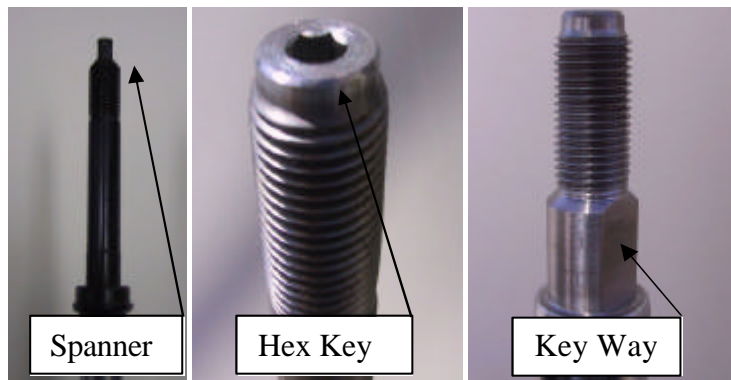
While installing a shock absorber, strut or cartridge, it is often difficult to prevent the piston rod from rotating when tightening the top mounting nut. KYB piston rods have been designed to allow for a Spanner (Figure 1), Hex Key (Figure 2) or Key Way (Figure 3) to hold the piston rod in position during fitment. The Key Way design locks the piston rod in the top hat mounting assembly preventing the piston rod from rotating.

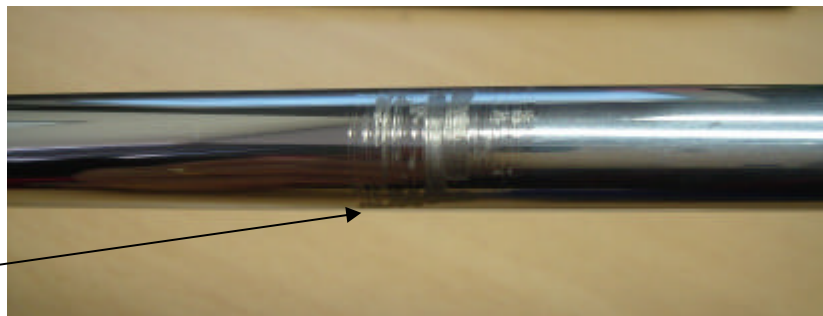
Every KYB piston rod is hard chromed to ensure a completely smooth surface guaranteeing perfect metal to seal contact. However, sometimes fitters use pliers, multi-grip or vice-grip type tools to clamp the piston rod while tightening the top mounting nut. This results in the piston rod becoming burred and scored by the teeth of the tool biting into it; consequently once the piston rod starts to compress and extend while in the vehicle, the burs quickly cut through the oil seal resulting in leakage. The suspension item is now damaged and not performing at its optimum level and needs to be replaced.

****What must be noted is that KYB do not cover incorrectly installed suspension products under warranty. The suspension item failed, not because of a faulty product, but due to incorrect installation.**

Burred and scored
Piston Rod.
